## **Look ~ do you see the noise leaking through that ceiling?**

Gary S. Madaras<sup>a)</sup>  
Rockfon  
4849 S. Austin Ave.  
Chicago, IL 60638

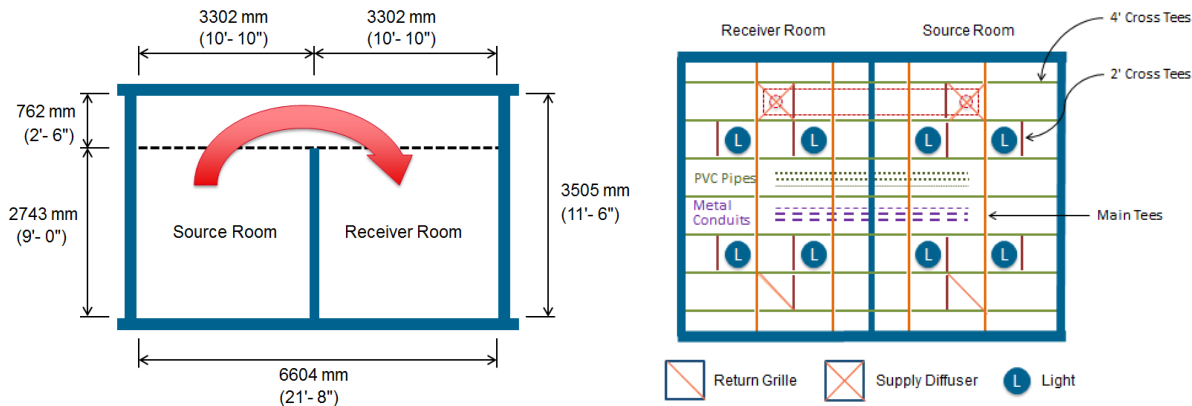
Fig. 1 – A section drawing showing the size and configuration of the test chambers (left) and a reflected ceiling plan drawing showing the layout of the suspended acoustic ceiling system including light fixtures, supply air diffusers, return air grilles as well as pipes, conduits and a duct in the plenum above the ceiling.

All testing was completed at NGC Testing Services in Buffalo, NY. The laboratory is accredited by the National Voluntary Laboratory Accreditation Program (NVLAP) (Laboratory Code 200291-0). Tests were performed according to ASTM E 1414 and E 413. Figure 1 shows the layout of the test chamber and the general layout of the ceiling system test specimens.

The suspension system was a standard 24 mm (15/16 inch) wide, 38 mm (1-1/2 inches) high, steel, tee-bar suspension grid. Refer to Figure 1 for the layout of the suspension grid and ceiling panels in the test chamber. The grid was installed in an uninterrupted manner, meaning the grid ran continuously over the central demising wall. When a plenum barrier was not included in the test, the ceiling panels ran continuously over the central demising wall.

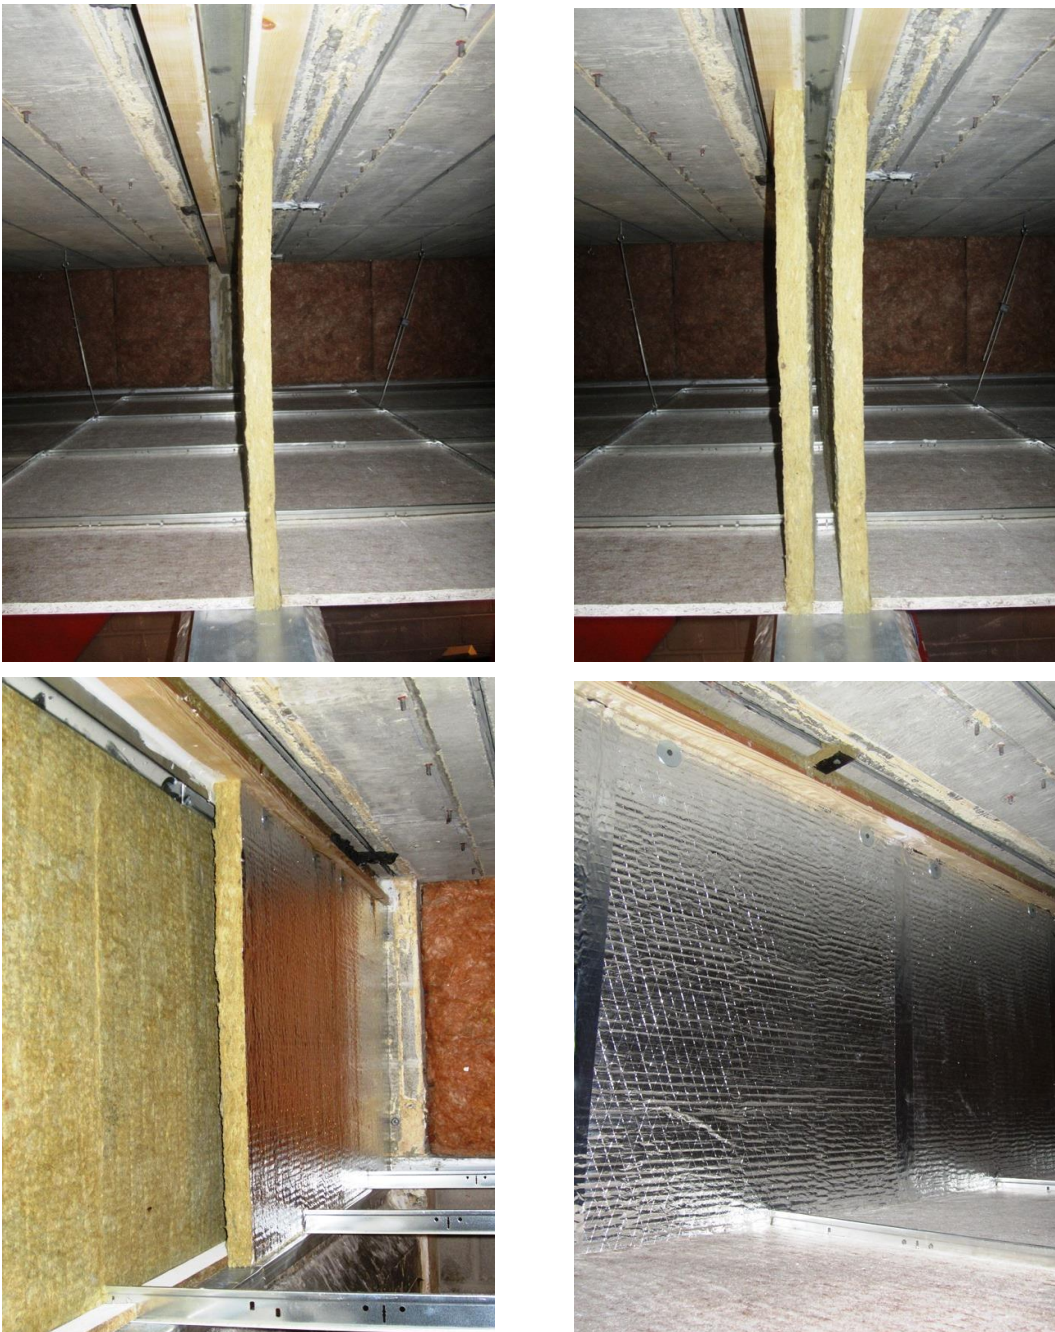
*Fig. 2 - Lightweight, stone wool, plenum barriers installed above the central demising wall of the laboratory's chamber during some tests. Top-left: Single-layer. Top-right: Double-layer with a 42 mm (1-5/8 inches) airspace in between. Bottom-left: Double-layer with seams staggered and small cuts at the bottom so the panels slide down over the grid bulb. Bottom-right: Intallation complete with tops screwed, seams taped and ceiling panels installed.*

Figure 2 shows how the plenum barriers were mechanically fastened along the top edge using common, self-tapping, sheet metal screws with insulation washers into a common 41 mm (1-5/8 inches) wide metal channel that was attached to the test chamber overhead slab. Screws were spaced approximately 305 mm (12 inches) to 457 mm (18 inches) on center. Typically, each 610 mm (24 inch) panel had two screws along the top. The bottoms of the plenum barrier panels were only friction-fitted against the top track of the demising wall and the grid. They were not mechanically fastened, glued or caulked. Each panel was abutted to the adjacent panels along the sides with no overlap. The vertical seams between adjacent panels were taped using 50 mm (2 inch) wide metal tape for sealing butt-joints. When the double-layer plenum barriers were tested, the 610 mm (24 inch) wide panels were staggered 305 mm (12 inches) so that the seams were not aligned. This required a small cut along the bottom of one layer of the plenum barrier panels so that they could slide down over the grid bulb and allow the bottom of the plenum barrier panel to sit on the top track of the demising wall. No caulk or sealant was used. Small gaps around and in between some of the plenum barrier panels were visible. Most gaps were closed during installation due to the pliability of the stone wool. The panels were cut slightly oversized and then compressed vertically and laterally during installation, which helped prevent gaps.

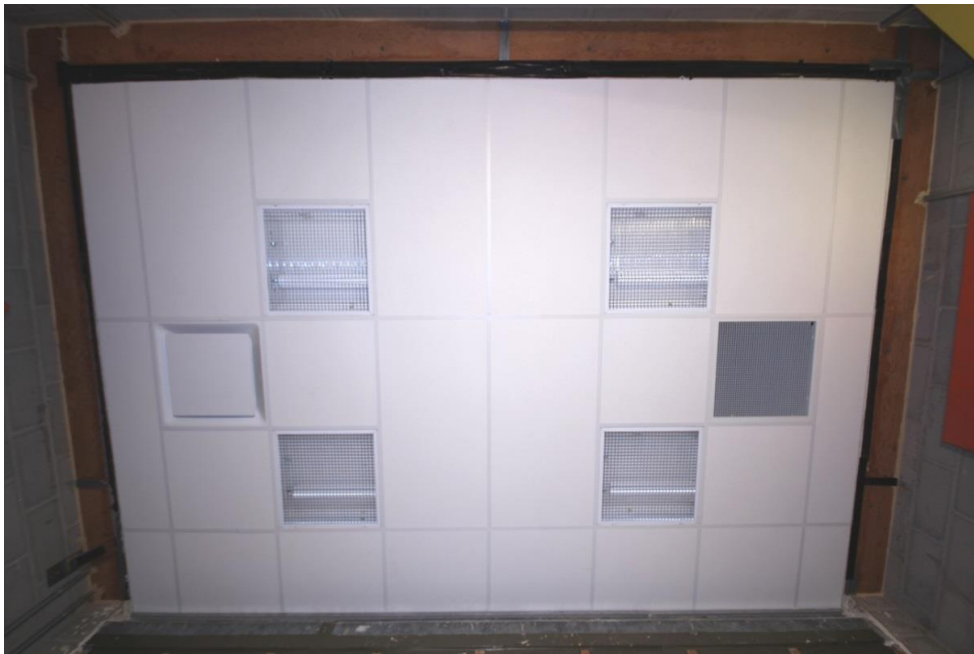
*Fig. 3 – The typical ceiling system configuration used throughout the testing with various acoustic ceiling panels suspended in a metal grid and with light fixtures and supply and return air devices.*

Figure 3 shows the typical ceiling layout in the chamber receiver room for reference purposes. The same ceiling layout was also installed in the adjacent chamber source room. The common wall between the two rooms, which stops at the underside of the ceiling and leaves the plenum open, occurs along the bottom of the image. The plaque-style, supply-air, diffuser is shown on the left side. The four recessed light fixtures are shown in the center. The return-air grille is shown on the right. Throughout the duration of the testing, different ceiling panels alone or different ceiling panel and plenum barrier combinations were installed and tested.

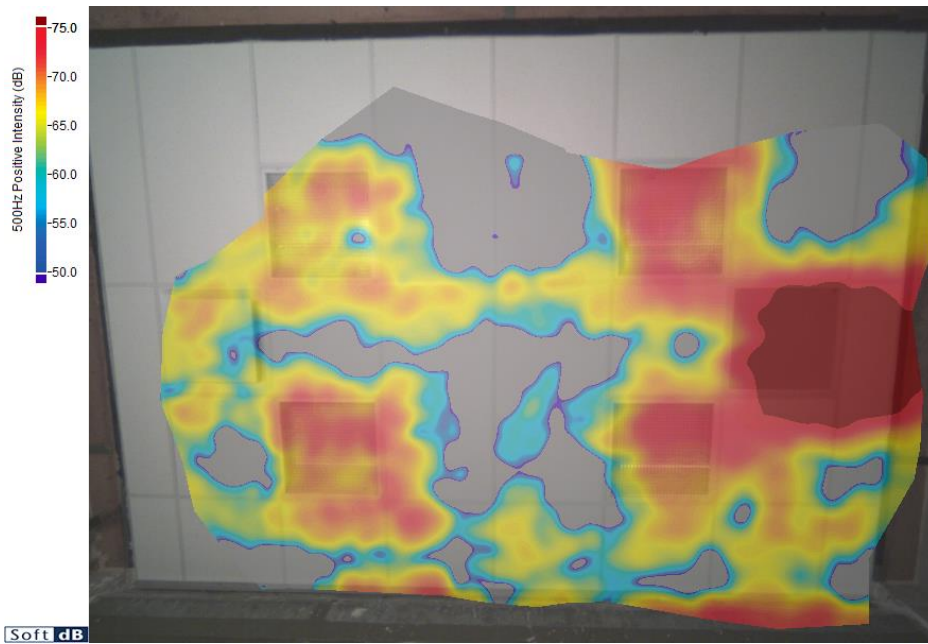
*Fig. 4 – A color map showing sound transmission through the ceiling, 500 Hz octave band, mineral fiber ceiling panels (NRC 0.60,  $CAC_{panel}$  37), no plenum barrier. The sound transmitting through the ceiling penetrations for lights and air devices decreases  $CAC_{panel}$  37 to  $CAC_{system}$  27.*

Figures 4 and 5 show two example color maps of sound transmitting from the chamber source room into the chamber receiver room via the plenum above the ceiling. In Figure 4, the test specimen included wet-formed, mineral-fiber, acoustic ceiling panels with a NRC rating of 0.60 and tested CAC rating of 37. The declared CAC rating was 35, two points lower. No plenum barrier was included. In addition to seeing a lot of noise leaking through the light fixtures and air devices, noise can also be seen leaking between the top of the wall and the underside of the ceiling along the bottom of the image. The combined effects of all the noise leaks are visually evident in red and yellow colors. Note that the entire ceiling was not scanned with the sound intensity probe. Some areas of the ceiling (e.g., top and left edges) do not have data/color overlaid. The noise leaks decrease the CAC<sub>panel</sub> rating of 37 down to a CAC<sub>system</sub> rating of 27, a 10 point decrease.

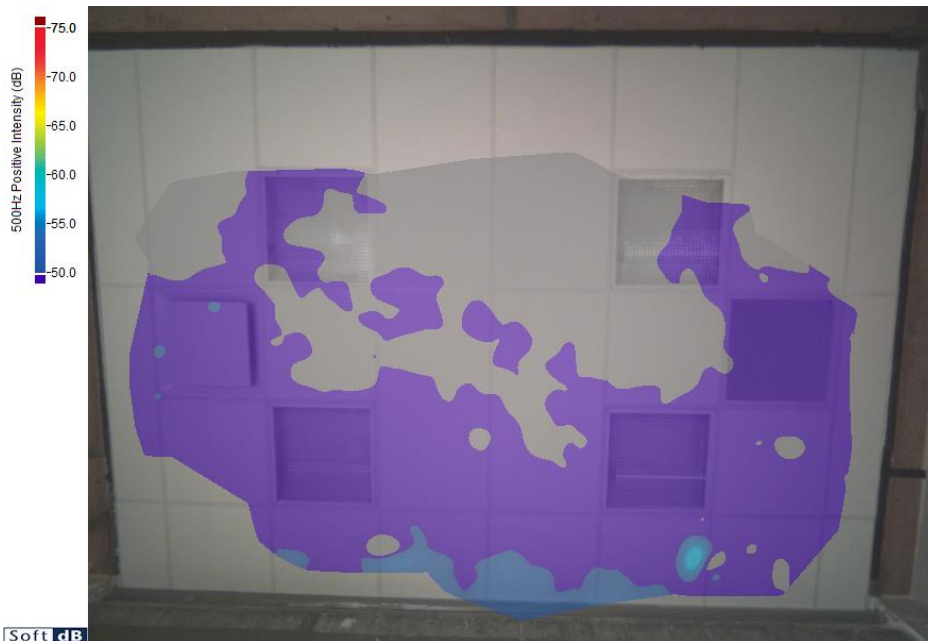
*Fig. 5 – A color map showing sound transmission through the ceiling and plenum barrier combination, 500 Hz octave band, stone wool ceiling panels (NRC 0.95,  $CAC_{panel}$  22), double-layer plenum barrier. Using a plenum barrier improved overall performance to  $CAC_{system}$  49.*

In Figure 5, the test specimen included stone wool acoustic ceiling panels with a NRC of 0.95 and a CAC<sub>panel</sub> rating of 22. A double-layer plenum barrier was installed. The improved acoustic performance is visually evident when compared with Figure 4. There are no red or yellow areas. The predominantly purple color map indicates that this design approach results in any transmitted noise being 20-25 dB lower in level. The use of the plenum barrier increased the CAC<sub>system</sub> rating to 49, despite the CAC<sub>panel</sub> rating being lower at 22.

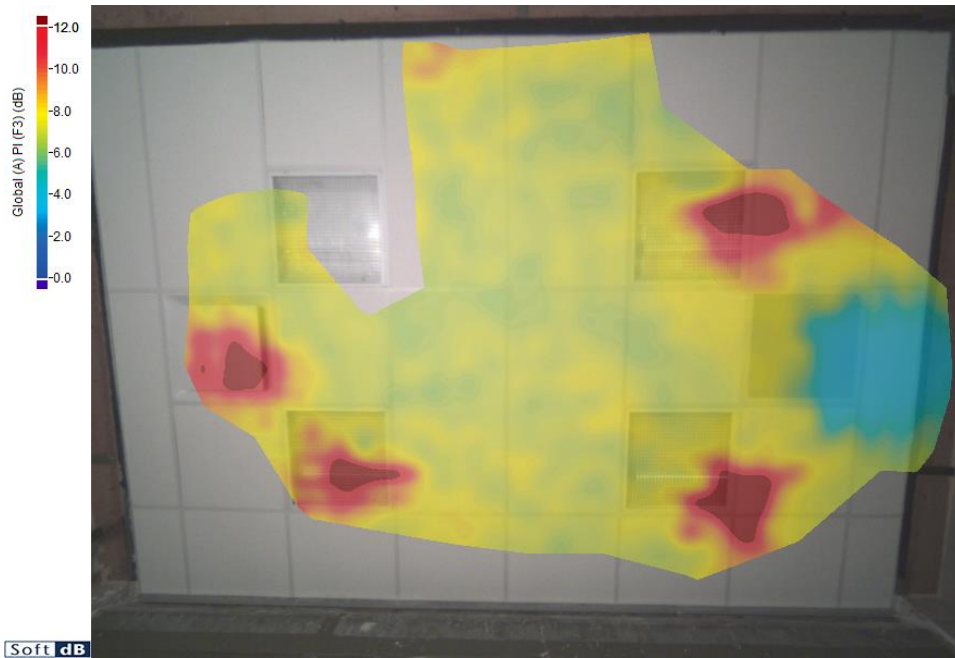
*Fig. 6 – A color map showing sound reflecting off a mineral-fiber panel acoustic ceiling with a NRC rating of 0.60 (yellow).*

Figures 6 and 7 show two example color maps of sound being either reflected off a low NRC ceiling or being absorbed by a high NRC ceiling. In Figure 6, the test specimen is wet-formed, mineral-fiber panels with a NRC rating of 0.60. During absorption tests, the presence or absence of a plenum barrier is irrelevant. It is useful to evaluate the sound reflecting off the ceiling panels (yellow) relative to that being reflected off the sound-reflective, metal, housings of the supply-air diffuser and light fixtures (red). The sound reflecting off the ceiling panels is only 3-4 dB less than that reflecting off these other hard surfaces. In contrast, the sound being 'absorbed' by the open return air grille (blue), represents complete absorption because the sound is passing through the grille. This area of the map is eight dB lower in level than that reflecting off the light fixtures and air devices. Ideally, as the color of the sound reflecting off the ceiling approaches blue, the absorption performance of the ceiling is maximized.

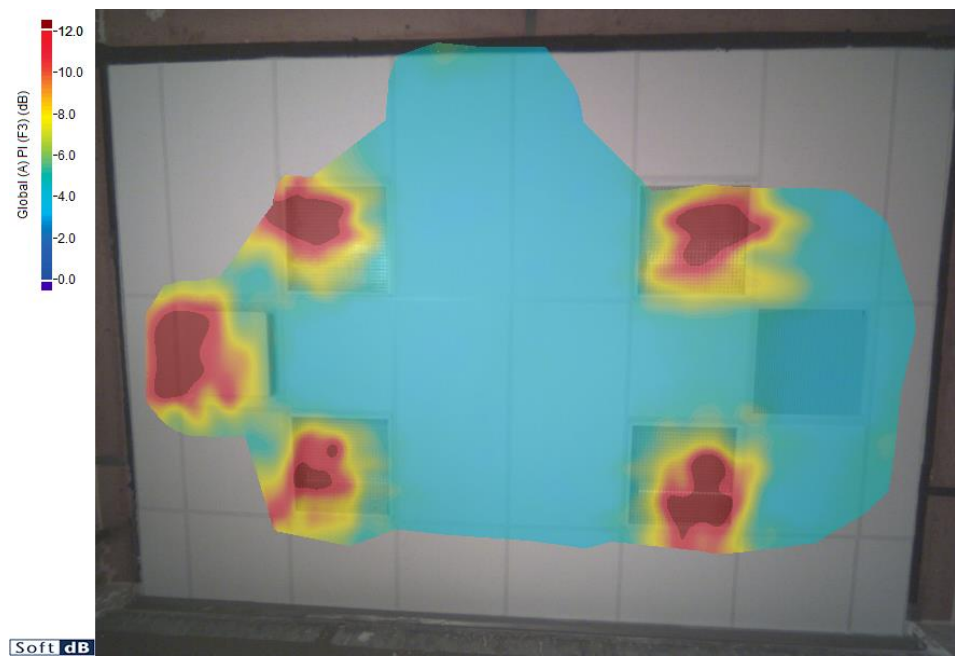
*Fig. 7 - A color map showing sound being absorbed by a stone wool panel acoustic ceiling with a NRC rating of 0.95 (blue).*

In Figure 7, the test specimen is stone wool ceiling panels with NRC rating of 0.95. In this example we see the sound not reflecting off the ceiling panels in blue color, the same ideal performance level provided by the open return air grille. The sound reflecting off the hard metal light fixtures and supply air diffuser is still shown in red and is approximately 9 dB louder than the sound reflecting off the ceiling panels.
